1. REPORT NO.		2. GOVERNMENT ACCESSION NO.		3. RECIPIENT'S CATALOG NO.	
4. TITLE AND SUBTITLE  SUBAUDIBLE ROCK NOISE (SARN) AS A MEASURE OF SLOPE STABILITY				5. REPORT DATE August 1973

SUBAUDIBLE ROCK NOISE (SARN) AS A  
MEASURE OF SLOPE STABILITY

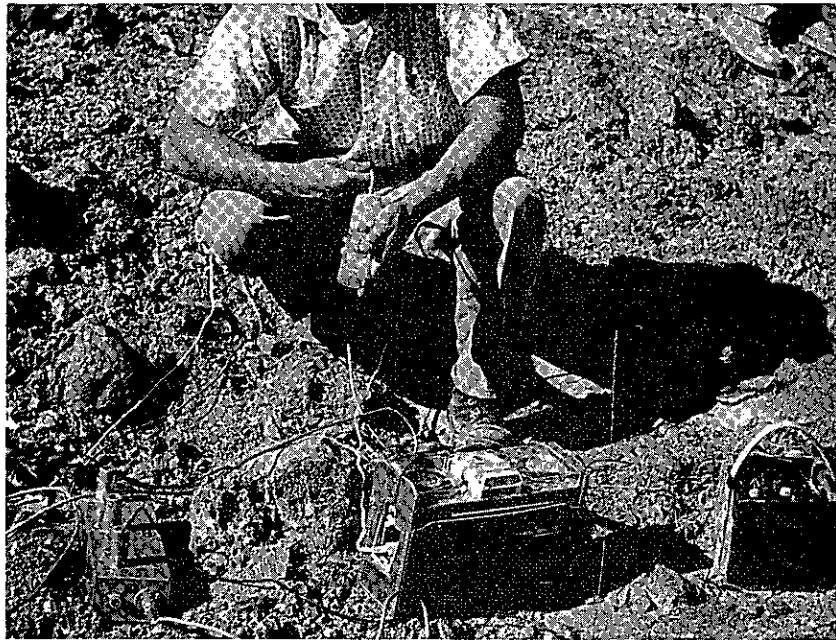
System 1 Field Equipment

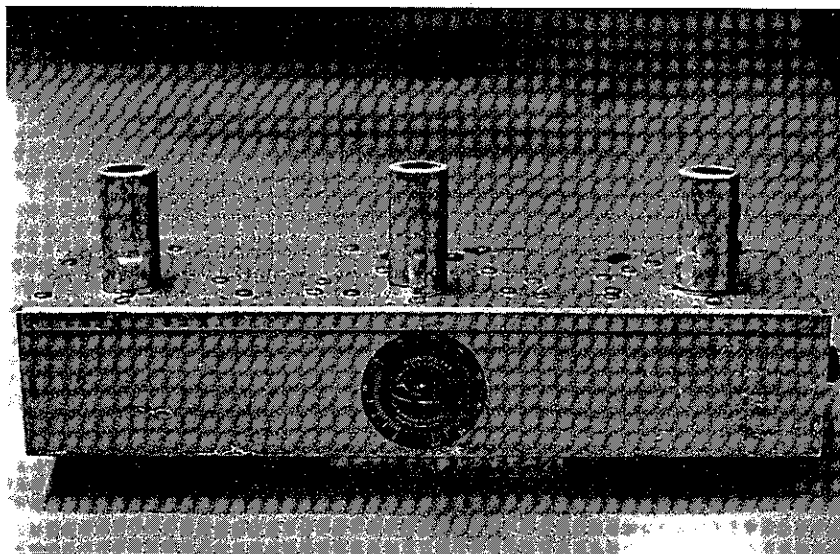
University of California Amplifier

A specially designed and constructed, tube type, amplifier.

LIMITATIONS: A narrow frequency response, extremely microphonic to airborne noises, requires an external power supply.

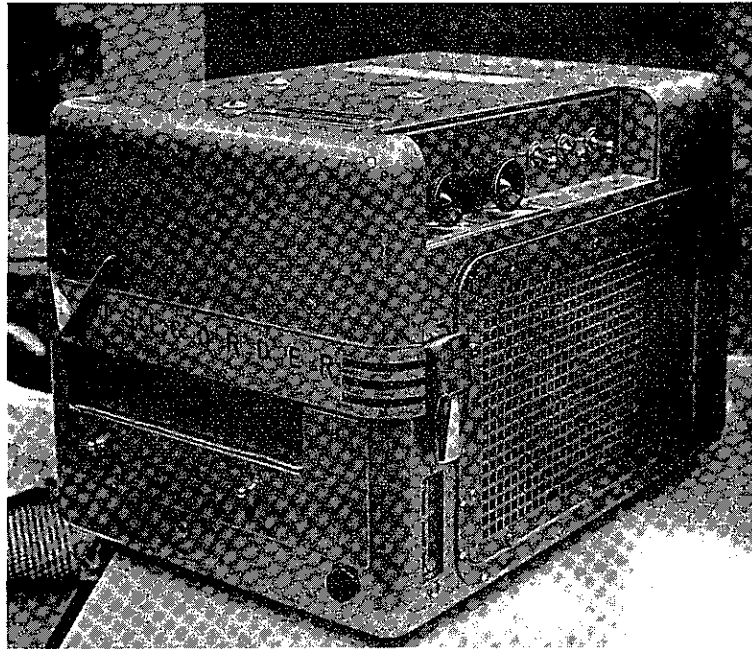
Honeywell Visicorder Model 906B  
SIZE: 14" x 10" x 9-1/2"  
FREQUENCY RESPONSE: 0-2,000 Hz  
LIMITATIONS: Must be used in Laboratory  
COST: \$3,900

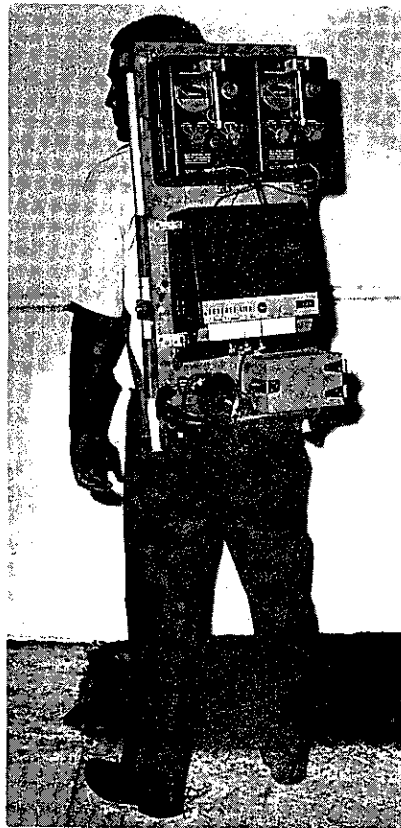
System 2 Field Equipment Mounted  
on a Pack Frame

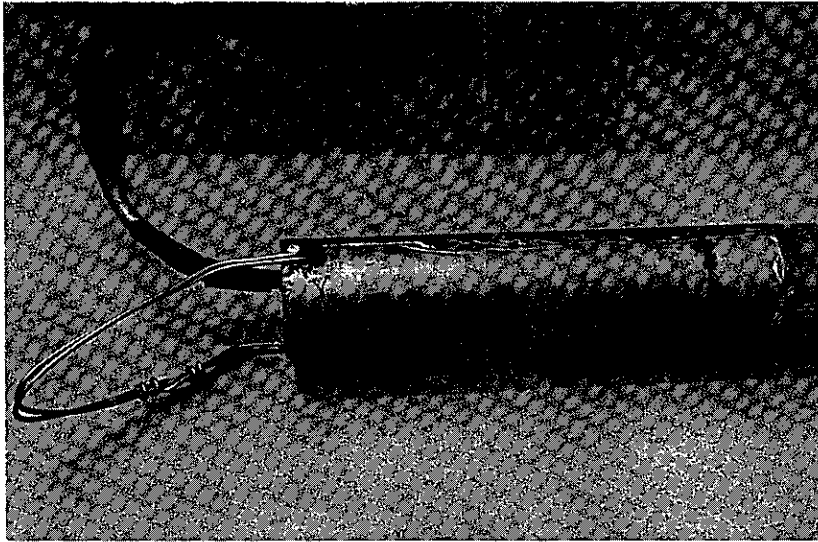
University of California microphone

A barium titanate ceramic disc mounted on  
a cantilever enclosed in a lucite case.

LIMITATIONS: Must be handmade

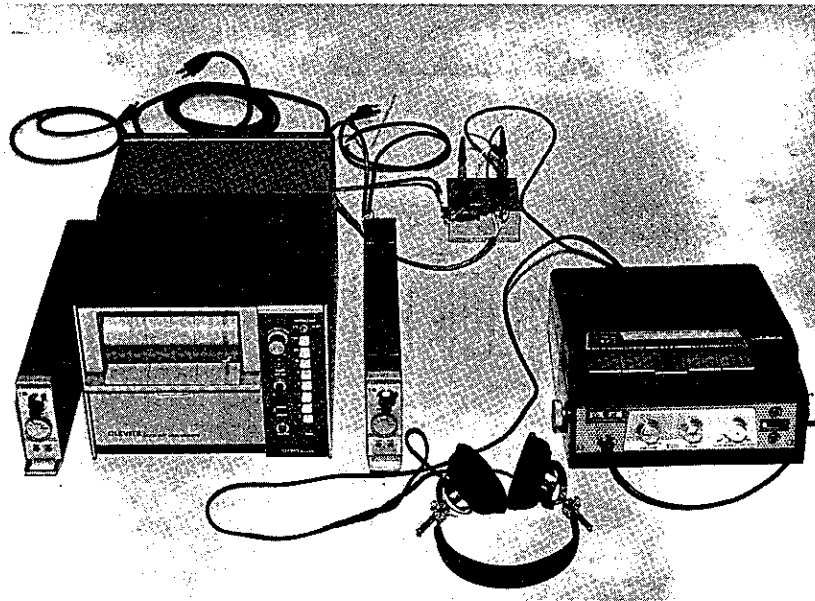
System 2 Laboratory Equipment

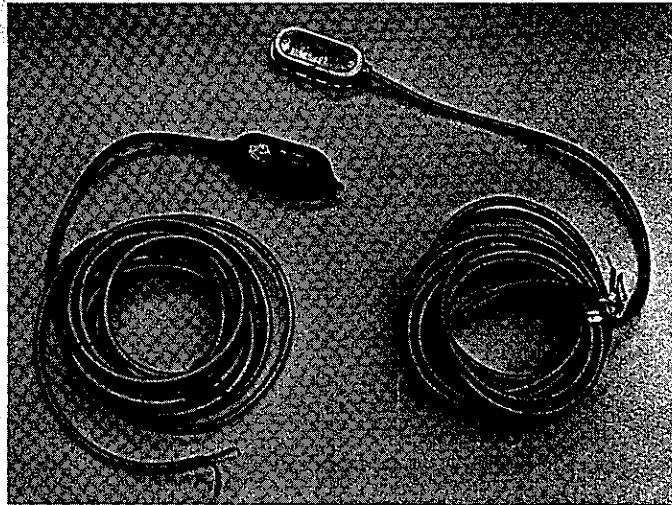
Electro Voice Model 805 Contact Microphone  
A rochellesalt crystal mounted on a cantilever  
in a zinc case.

SIZE: approximately 2-1/4" x 1-1/16" x 1/2"

LIMITATIONS: Must be water sealed, crystal  
melts at high temperature (over 110°F).

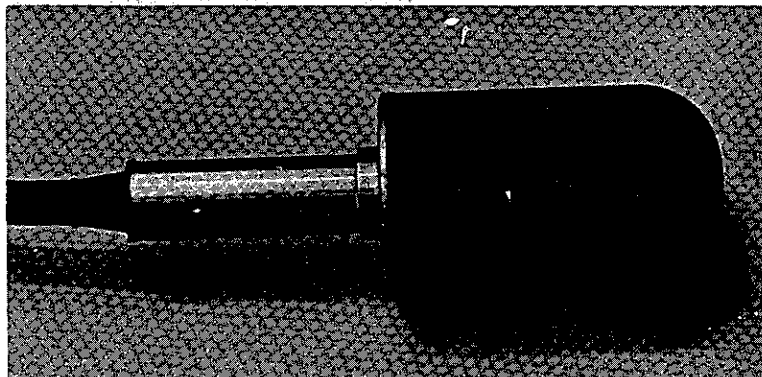
Atlantic Research Corporation Model LC-50  
Hydrophone

A piezoelectric transducer, it generates a signal with pressure changes using lead-zirconate titanate as the sensing element.

LIMITATIONS: Usable for SARN less than 5,000 Hz

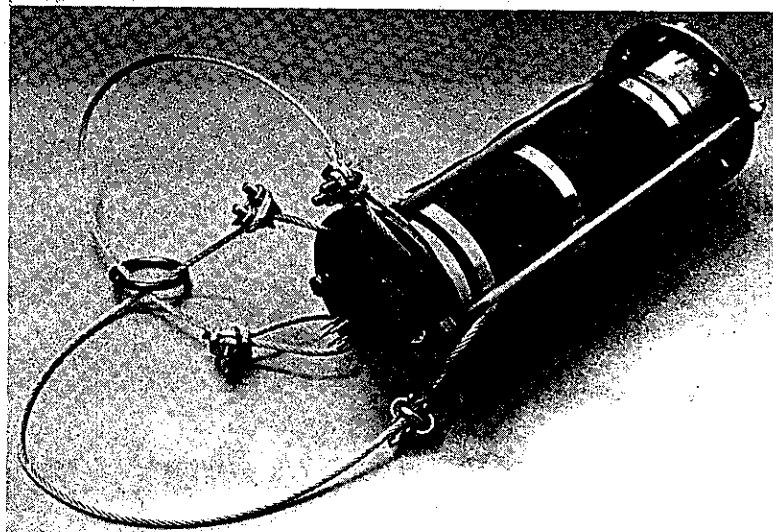
Chesapeake Model PC-101A Preamplified Hydrophone  
A preamplified lead-zirconate titanate piezo-electric transducer.

SIZE: approximately 3" diameter 12" long

(Suspended in water.) It also requires an external power source.

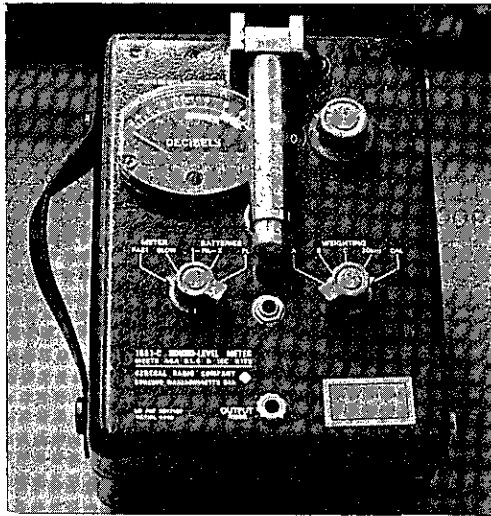
General Radio Company Sound Level Meter -  
Model 1551-C9703

A tube type high gain amplifier.

LIMITATIONS: Requires warm-up time.

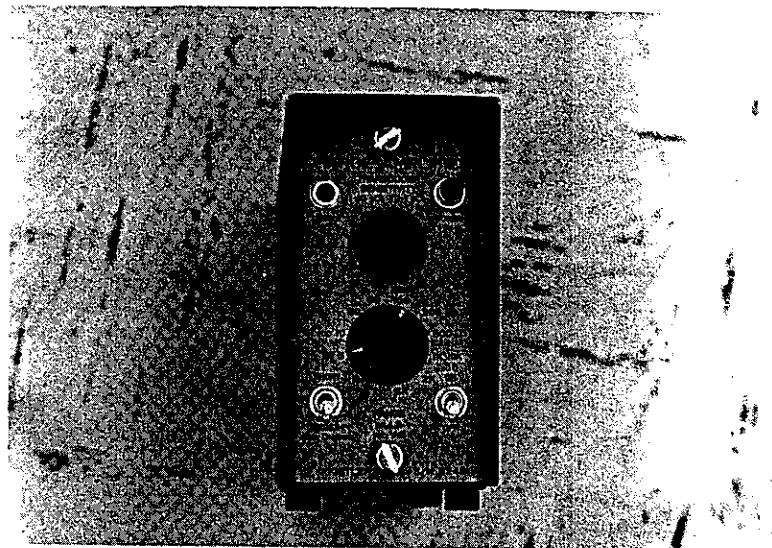
Kistler, Charge Amplifier - Model 5532  
A solid state charge amplifier.  
SIZE: approximately 3" x 6" x 9"  
FREQUENCY RESPONSE: 50-100,000 Hz  
LIMITATIONS: Charge amplifiers are not  
acceptable for low amplitude signals.  
COST: \$662.00

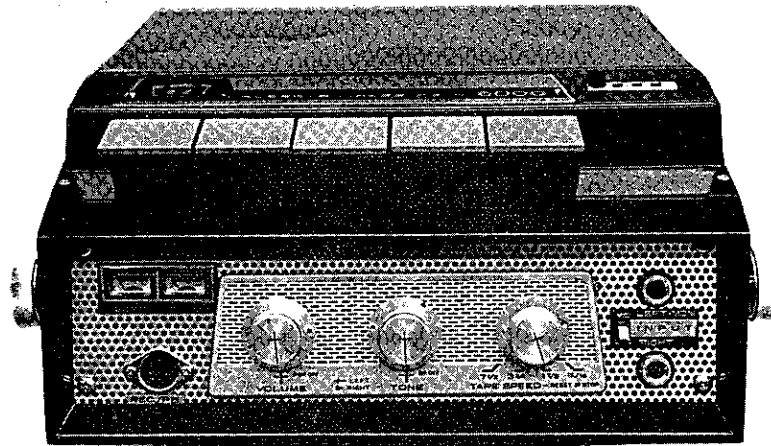
Roberts Model 6000S Tape Recorder  
A battery-operated stereo tape recorder  
using cross field recording.  
SIZE: approximately 5" x 11" x 12"  
FREQUENCY RESPONSE: 20-7,000 Hz  
LIMITATIONS: Must be battery operated to  
eliminate 60-cycle pulses, is only 2 channel.  
COST: \$375

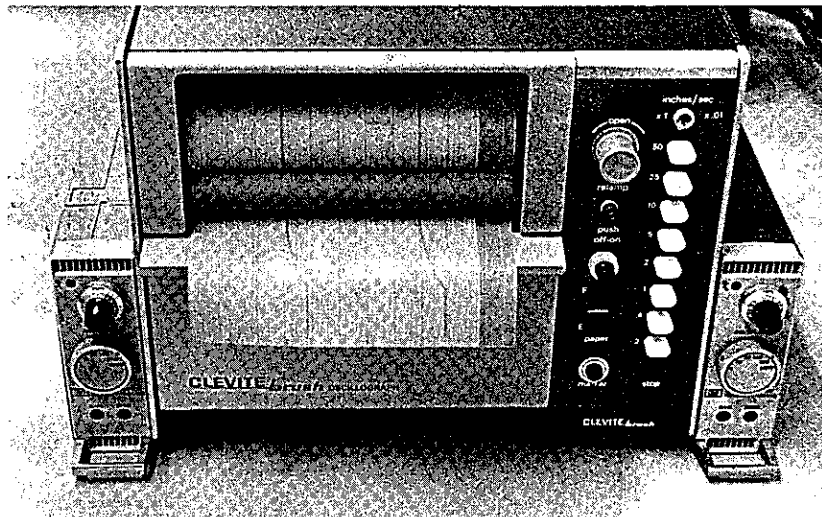
Clevite Brush Model 16-2300-00 Oscillograph Recorder  
An 8-channel oscillograph  
SIZE: approximately 19" x 11" x 9"  
FREQUENCY RESPONSE: 2-6,000 Hz using 5,000  
cps galvanometers.  
LIMITATIONS: Must be used in Laboratory.  
COST: \$2,405

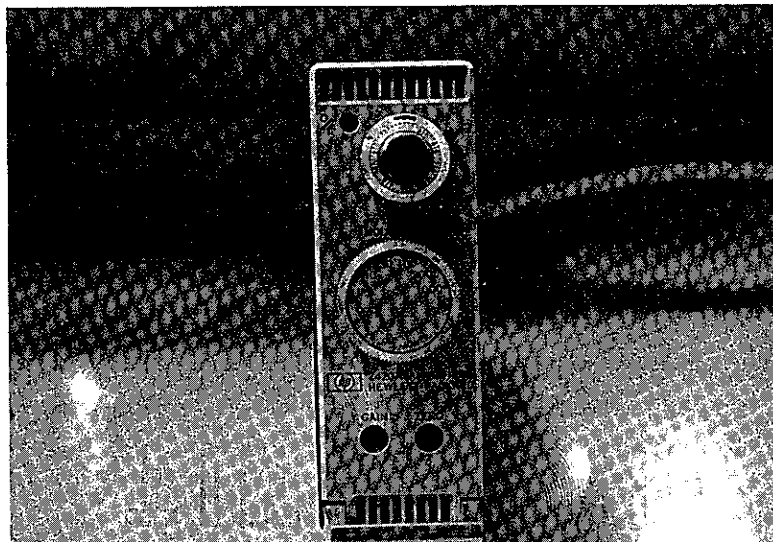
Hewlett-Packard Model 2470A High-Gain  
Data Amplifier

A high-gain differential amplifier for  
reliable amplification of low-level noises.

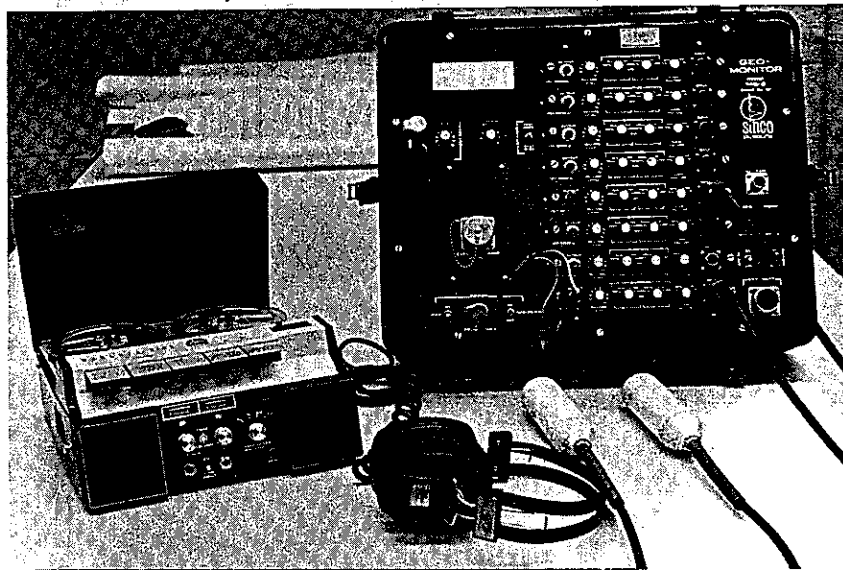
System 3 Field Equipment

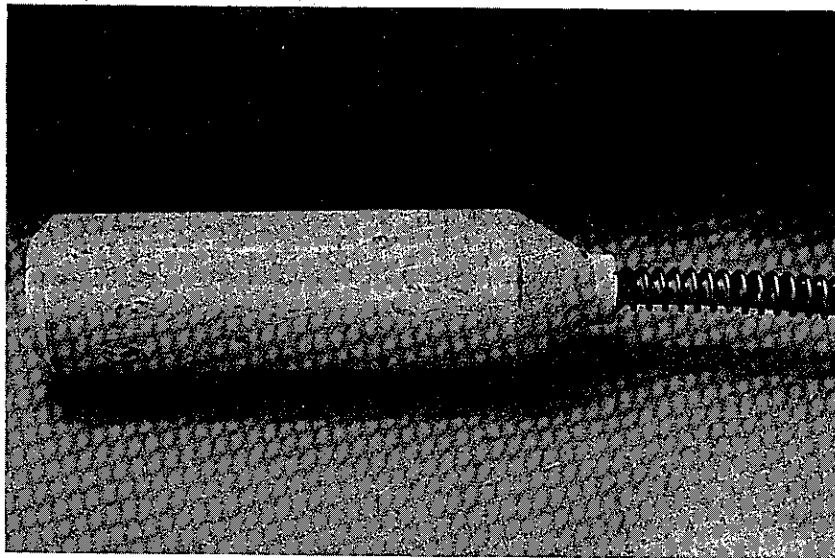
Geo-Recon Preamplified Transducer

A lead zirconate titanate ceramic transducer in a solid casing.

LIMITATIONS: Fairly large size.

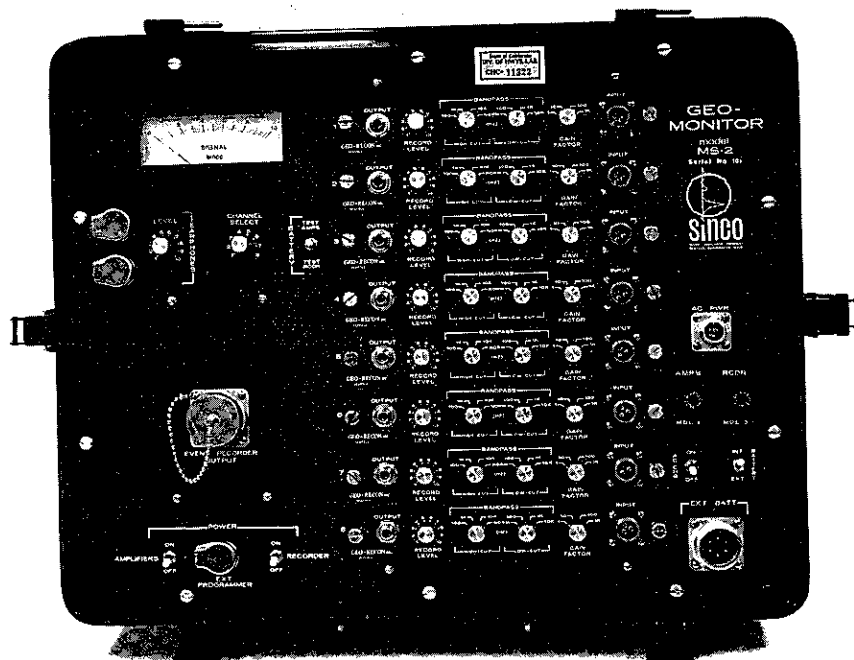
Geo-Recon Model MS-2 Noise Monitor  
 Amplifier System  
 An 8-channel, solid state noise monitoring  
 system.  
 SIZE: approximately 20" x 9" x 16"  
 FREQUENCY RESPONSE: 4-40,000 Hz  
 LIMITATIONS: Poor fidelity, not readily portable.  
 COST: \$5,140

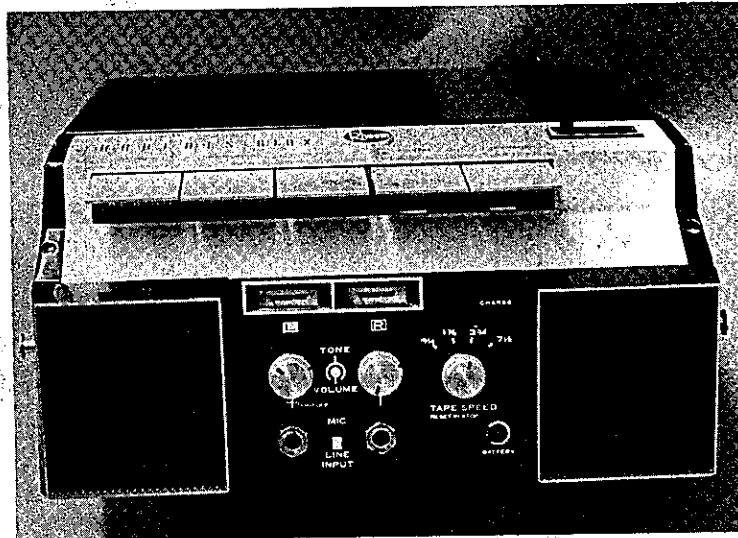
Roberts Model 610X Tape Recorder  
SIZE: approximately 5" x 11" x 12"  
FREQUENCY RESPONSE: 20-7,000 Hz  
LIMITATIONS: Must be battery operated to  
eliminate 60-cycle pulses, is only 2 channels.  
COST: \$227

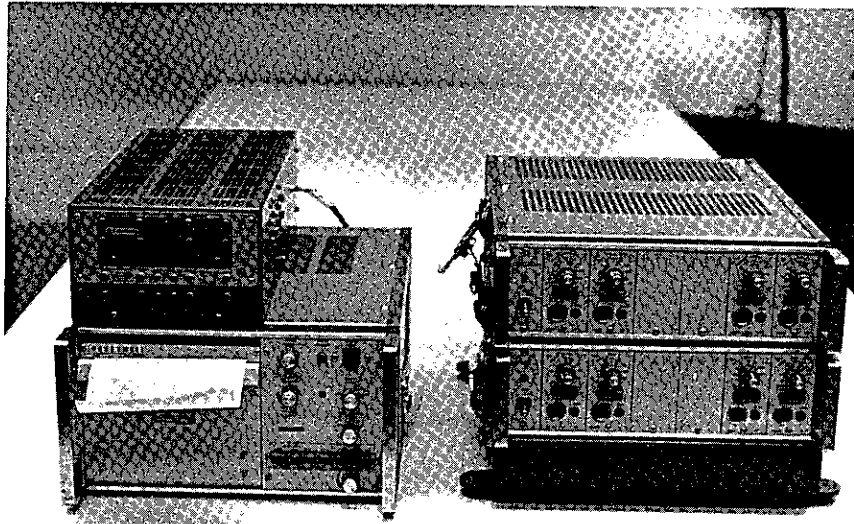
Honeywell Model SN.2-262-AFC

Visicorder System

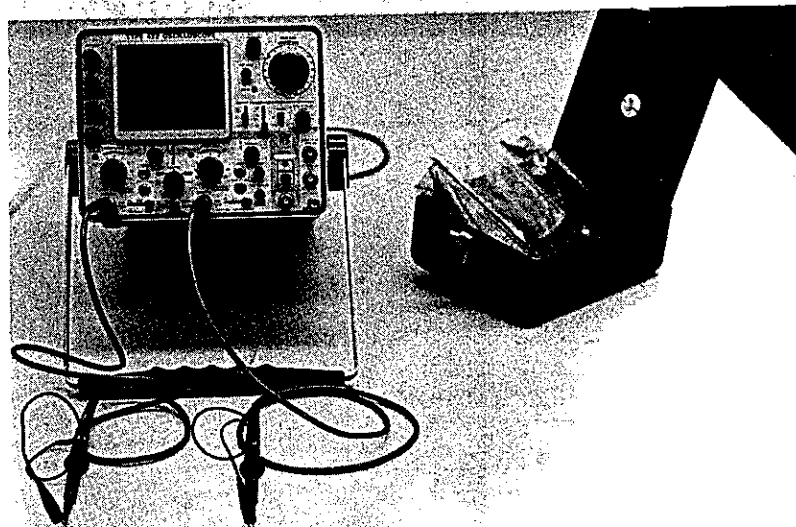
Tektronix Model 422 Dual Trace Oscilloscope  
A portable oscilloscope with two input channels.  
SIZE: approximately 7" x 7" x 14"  
FREQUENCY RESPONSE: 0-15,000,000 Hz  
LIMITATIONS: Only two channels.  
COST: \$2,050

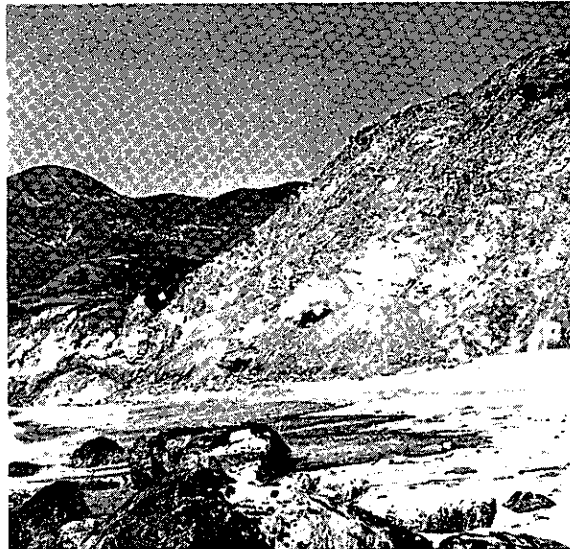
Landslide

In March of 1970 a section of the ocean bluff adjacent to California Highway 1 collapsed as the result of undercutting by surf action. The south abutment of a 38 year old concrete arch bridge was located immediately outside the head of the slide. Cracks were found within a few feet of the structure foundations and the approach fill to the abutment settled several inches.

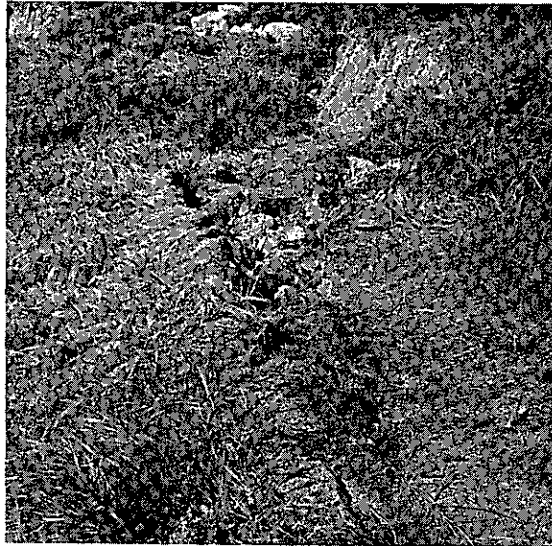
Cracks at Head  
of Landslide

Monitoring locations were selected in the slide mass, in various fractures at the head of the slide, and adjacent to the foundation of the structure. The monitoring was started within four days of the original slide and the initial SARN rates were sufficiently high to warrant concern. Around the clock monitoring was started and it was immediately observed that the SARN rate increased gradually as the tide came in and that at the time the tide began dropping the SARN rate decreased suddenly. Based on this observation, it was decided to only monitor the incoming tide cycles. After two days the noise rate became regularly lower and at the end of two weeks had stabilized. Monitoring was terminated at that time.

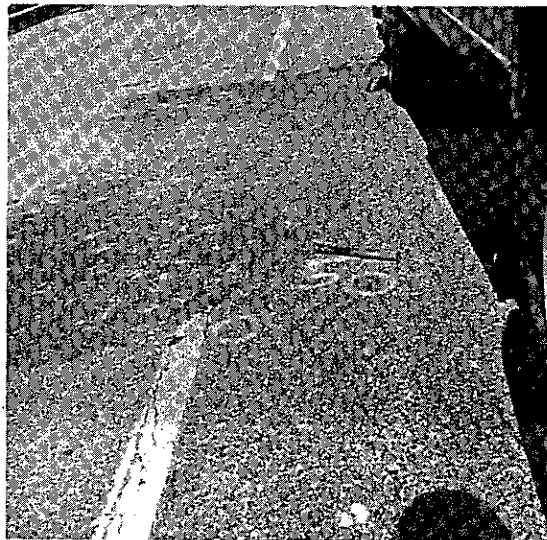
Cracks in Pavement  
of South Bridge Approach

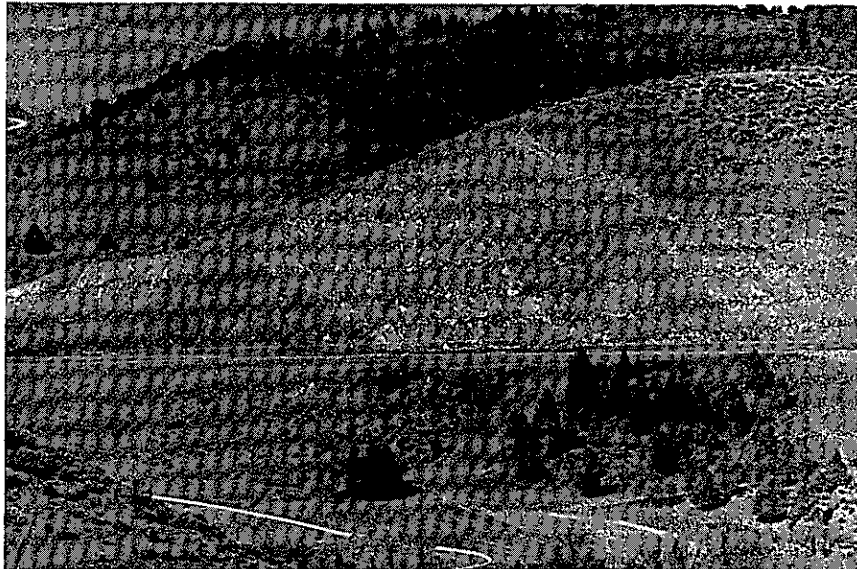
Sta. 810 Cut Slope where small  
Failure occurred.

A small failure involving the edge of a bench did occur in one cut slope. It was near a monitoring site and the noise rates at that time were 1.1, 3.3, 2.2, and 1.5 events per minute.

The failure occurred sometime between the 3.3 and the 2.2 readings. It is believed that had readings been taken in that interval a clear pattern of increasing SARN would have preceded the failure.

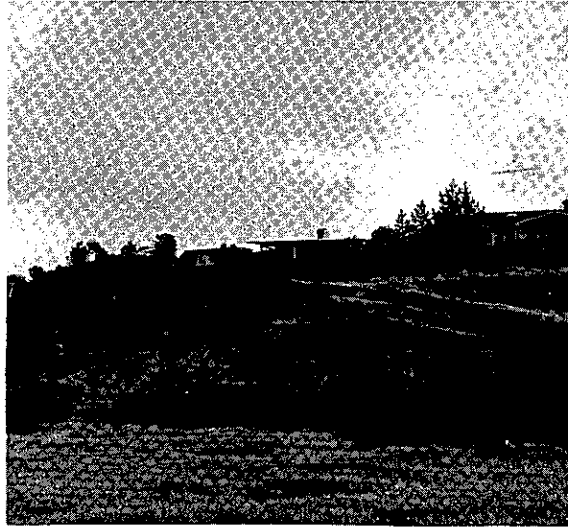
Landslide from Below  
Note Houses above the Head

A relatively small landslide had developed below a county road and had begun to cause roadway displacement. This facility, which provided access to an extensive housing area, appeared to be in danger of failure. Also, enlargement of the slide headward would have endangered two homes on the uphill side of the road. Another house downhill from the slide had experienced severe damage to its driveway and appeared to be endangered if the roadway collapsed.

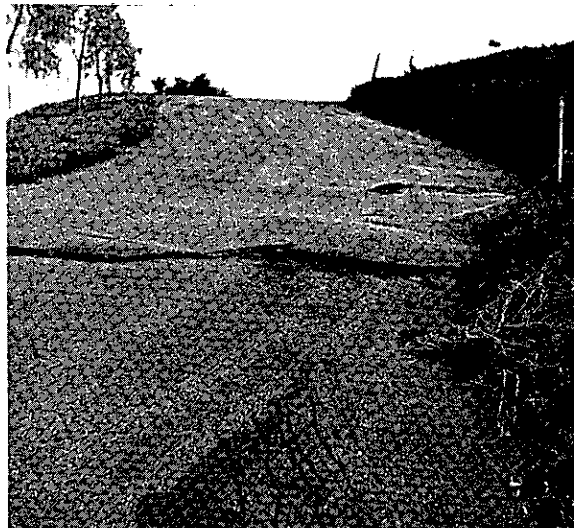
Damaged Driveway to  
House Below the Slide
